**BACKGROUND:** (30.4.2013)

**SAFETY ALERT**

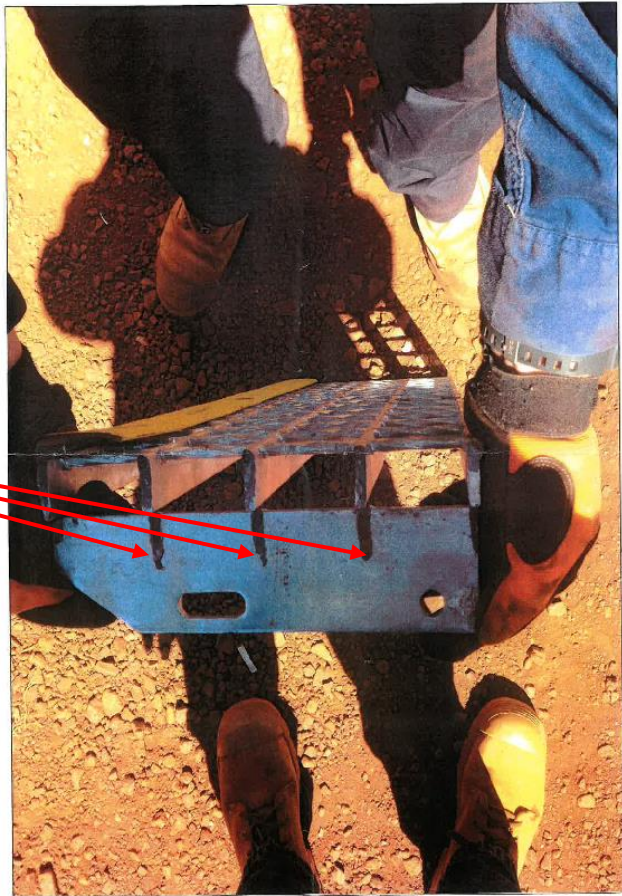
A modular scaffold plank being used in the resource sector in West Australia has failed. It has been reported, by the scaffolders using the scaffold gear, that a batch of planks imported from overseas is responsible for the failure.

The issue seems to be surrounding the failure of a weld which should be either side of the cleats (see attached picture) but we have information stating that only one weld is present which has contributed to the failure.

Failed welds, only one side welded.

- All plant and equipment meet the relevant Australian Standards.
- All plant and equipment is design registered as per applicable legislation.
- Importers of plant and equipment to ensure compliance with all Australian Standards and legislation before sale or use in the industry.
- Any new plant and equipment brought onto site to be checked for compliance.
- Check all welds on modular scaffold planks before use.
