BACKGROUND: (25.7.2013)

Blanket Containing Chrysotile Asbestos

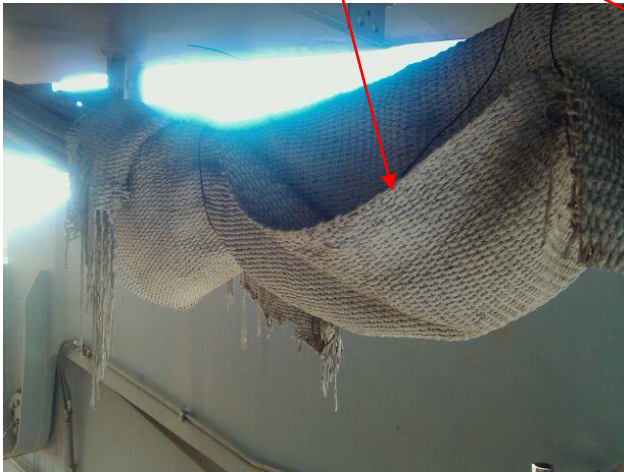
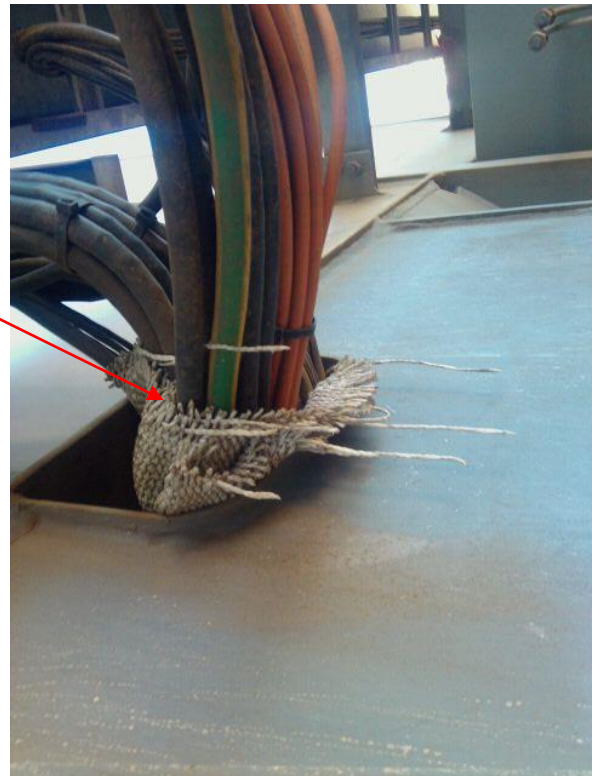
It has been discovered that two sections of plant (reclaimers) which have been imported from China, have been transported along with a type of fire blanket, this blanket has been used to protect cabling within the plant from damage during transit. Tests carried out on the 20th July have confirmed the presence of Chrysotile Asbestos in the material used to manufacture the blanket. The plant has since been isolated and the material is being removed by competent persons.

- Ensure that any packaging imported along with any plant or equipment does not contain any hazardous materials that could pose a risk to workers when unloading or installing.
- Companies receiving imported plant or machinery should contact either the manufacturer or the importer to inform them that material containing hazardous substances may not be used in any packaging that is to be imported into Australia.
- Any packaging found to contain hazardous substances should be isolated immediately and removed by competent persons.
- All hazardous materials should be adequately labelled for easy identification.
